Property Inspection Report

123 Customer Ln. Your City TX 75123

PROPERTY INSPECTION REPORT

Prepared For:	Your Name Here		
	(Name of Client)		
Concerning:	123 Customer Ln., Your City, TX 75123		
	(Address or Other Identification of Inspected Property)		
Ву:	Chris Cordier Texas License #: 22494 / Every Angle Inspectors	1/1/2050	
	(Name and License Number of Inspector)	(Date)	
	(Name, License Number of Sponsoring Inspector)

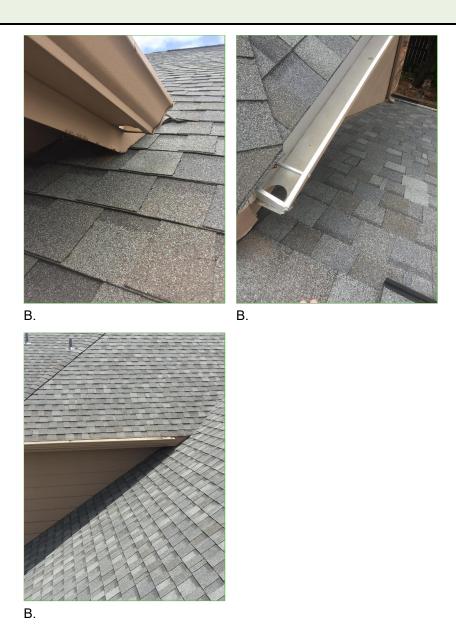
(1) Gutters are terminating on the roof. They should have individual downspouts that terminate at grade level. This set up will result in lessoning the life of the roof covering materials in that area.

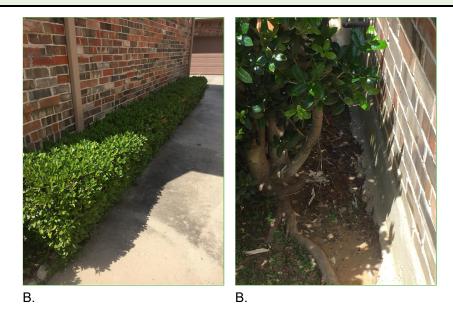
(2) Shrubbery too close to property. All shrubs/trees should be at least 1.5 feet away.

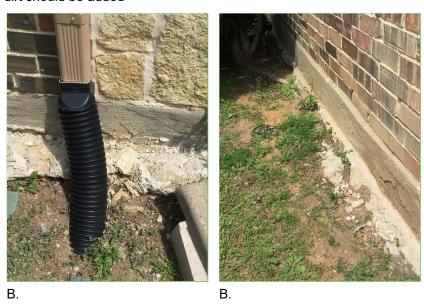
(3) Grading next to house is too low exposing too much of the foundation on the West side of house. Extra dirt should be added

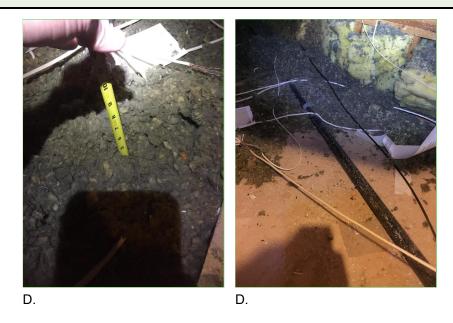
(3) Average insulation depth is only 5 inches. It should be at least 10 inches. There are also bare spots of insulation over the living room.

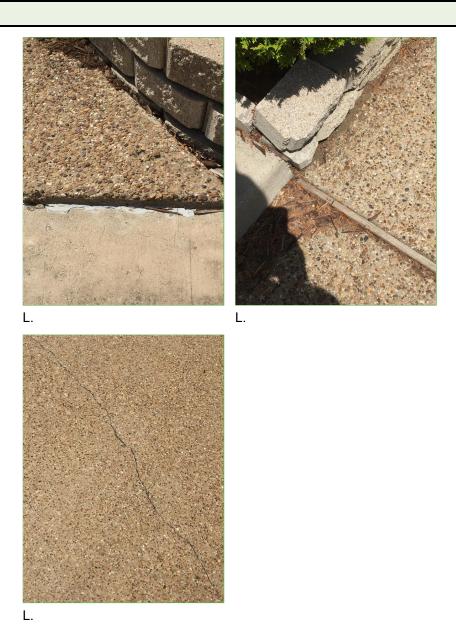
(1) Driveway has some small cracks and some uneven areas present tripping hazards.

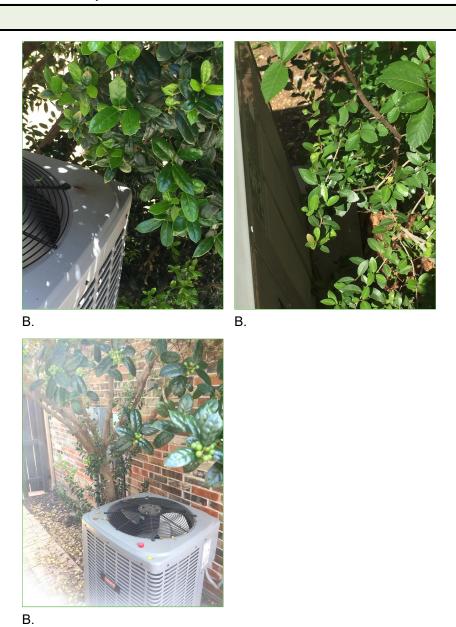
(1) Shrubbery too close to condenser unit. All shrubs/trees should be at least 2 feet away.

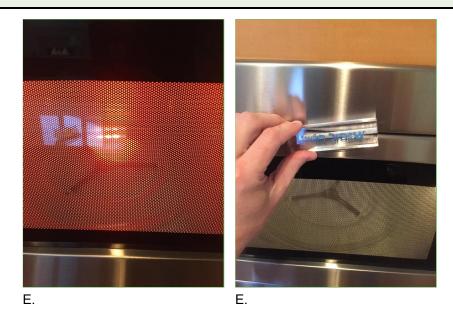
The microwave is operational with no radiation leaks detected.
